## **Parcel C Remedial Action**

# **Project Update for Parcel C Hunters Point Naval Shipyard San Francisco, California**

**BCT Meeting October 24, 2013**

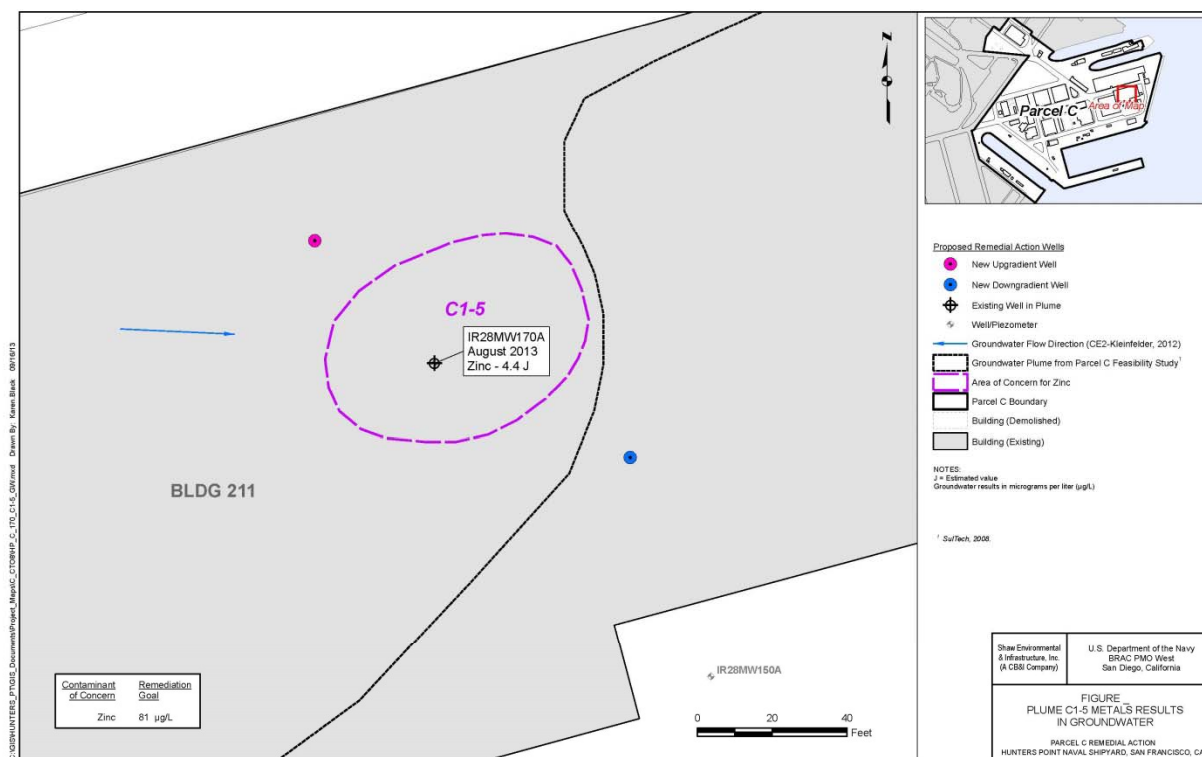
## Sample Results for Zinc in Groundwater – IR28MW170A (Plume C1-5)

- Parcel C FS (Sultech, 2008; Parcel C FS) identified elevated zinc (1,300 ug/L) at well IR28MW170A and recommended the plume be remediated by anaerobic bioremediation
- Parcel C RD identified the plume as C1-5
- Well IR28MW170A was recently sampled as part of the remedial action plume characterization for zinc (August 2013)

- The only historical sample containing zinc above the Parcel C ROD Remediation Goal and surface water quality criteria appears to have been an anomaly
- The validation report did not include validation of sample ID 0228E019, collected on 7/11/02
- Historic and recent filtered groundwater sample shows zinc below the RG and surface water quality criteria
- The anomalous high result was not validated and is not representative of the groundwater of that area or concentration trends.
- **Recommend removal of Plume C1-5 from areas requiring remediation**
